Technical Report

Drinking Water System at the Kashechewan First Nation

Ministry of the Environment

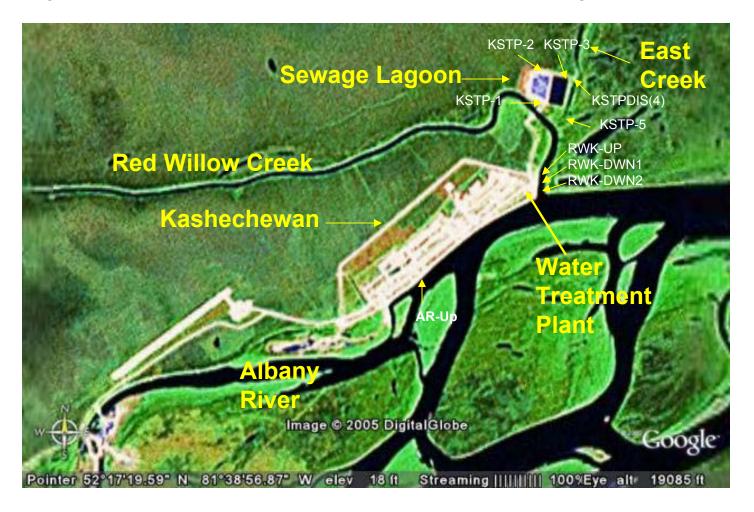
Figure 2: Kashechewan First Nation and Surrounding Area

The raw water intake for the plant is a 200 mm diameter pipe that extends approximately 90 m into the creek. The intake crib (end of pipe) is located in the vicinity of where the creek feeds into the Albany River at a depth of 4.5 m. Staff of Public Works Canada has witnessed a reversal of water flow in the Albany River due to the tides in James Bay. This phenomenon could influence the raw water quality at the intake. Refer to figure 2 for further details

A basic sampling program was conducted as part of this assessment. These sample sites are illustrated in Figure 2. The analytical results obtained from these samples are summarized in the attached Appendix D. Samples were obtained from Red Willow Creek at locations upstream (RWK-UP) and downstream of the community's storm water outflow (RWK-DWN1), and downstream near its confluence with the Albany River (RWK-DWN2). Samples were also obtained at an upstream sample location on the Albany River (AR-UP) and from East Creek at its confluence with discharge from the sewage lagoon (KSTP-4) and upstream where the creek is crossed by the winter road (KSTP-5). A review of this analysis reveals that water quality within Red Willow Creek did not vary significantly between upstream and downstream stations. In addition, there was no indication of an abnormal concentration of any water quality parameter within samples taken from East Creek, Red Willow Creek and the Albany River.

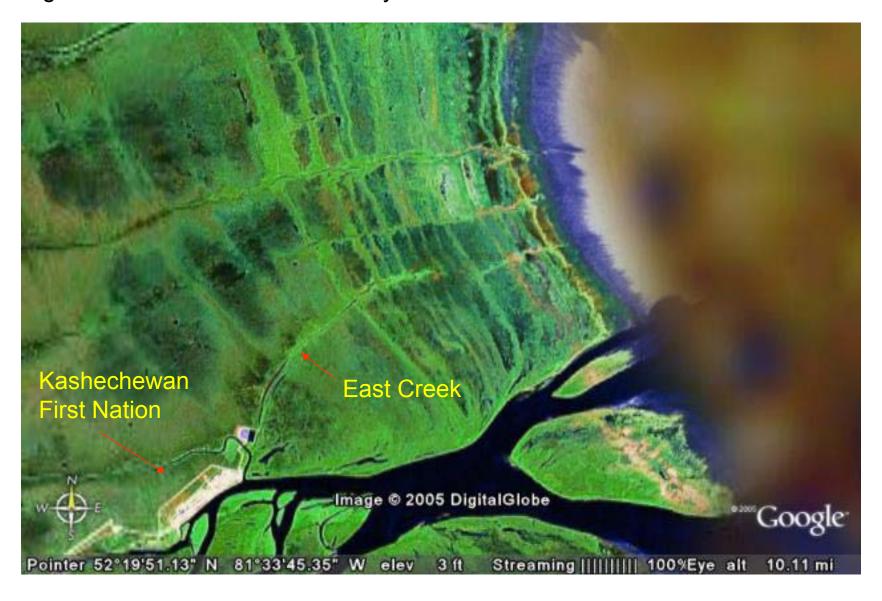
Figure 6: East Creek to James Bay

Treated effluent from the discharge chamber enters a 5 m wide ditch that leads to East Creek. East Creek flows in a north-easterly direction for a distance of approximately 8 km from the sewage lagoons towards James Bay (Figure 6).
